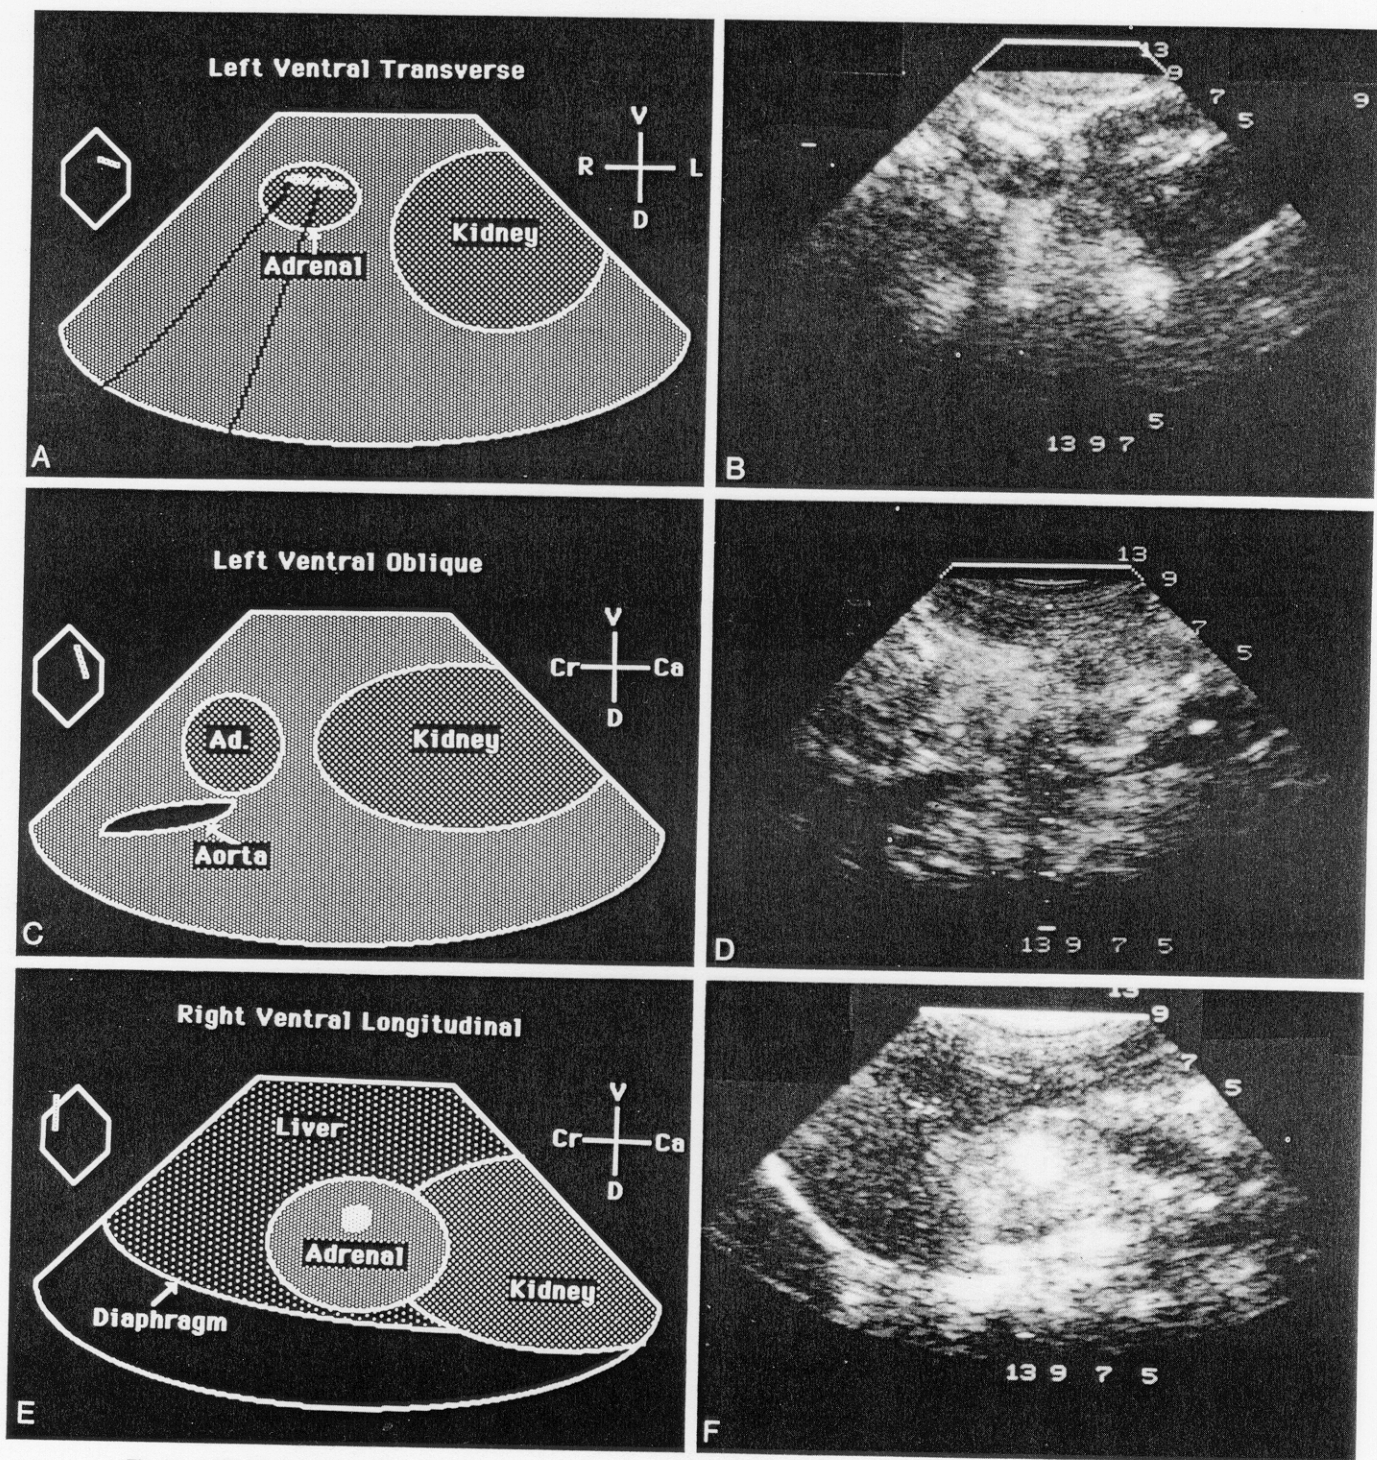
Figure 118-16. A, Diagrammatic illustration of the ultrasound image shown in B, showing the appearance of a calcified adrenal carcinoma in a dog with hyperadrenocorticism. C, Diagrammatic illustration of the ultrasound image shown in D, showing a hyperplastic adrenal gland in a dog with PDH. E, Diagrammatic illustration of the ultrasound image shown in F, showing the opposite hyperplastic adrenal in the same dog with bilateral adrenal hyperplasia. V, ventral; D, dorsal; Cr, cranial; Ca, caudal; the symbol in the upper left corner of A, C, and E is the location and orientation of the transducer in the ventral abdomen. (A, C, and E used courtesy of Dr. Brett Kantrowitz; B, D, and F from Kantrowitz BM et al.: *Vet Radiol* 27:15, 1986. Used with permission.)
